Hurlbert Home Inspection, LLC

CONFIDENTIAL INSPECTION REPORT

1234 YourNew Street, Hometown, VA 987654

SUMMARY REPORT

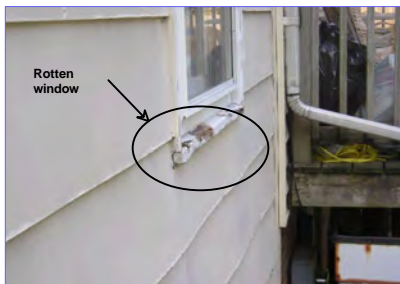
Fascia and Trim

- ✓ The wooden fascia and trim on the outside of the house has peeling paint and rot. The rotten wood should be replaced and repainted. This may be an indication of delayed or poor maintenance. There may be other areas that need repair that were not observed. Also the amount and depth of any moisture penetration cannot be determined until the damaged area is removed.

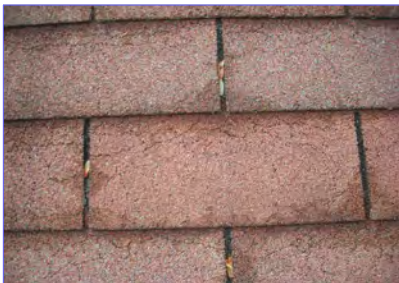
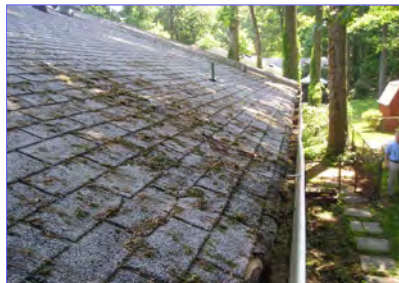
Roofing Material

- q The roof is in the is showing sighs of decomposition, which means that the roof is in decline and susceptible to leaks. It will need to be maintained and closely monitored, because it is reaching the end of its serviceable life.

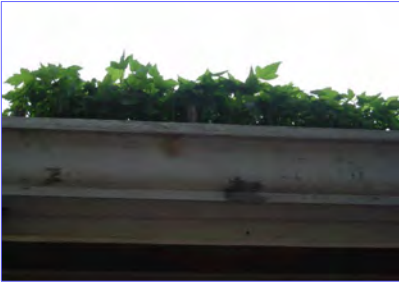
Gutters and Drainage

- q The gutters need to be cleaned to drain properly.

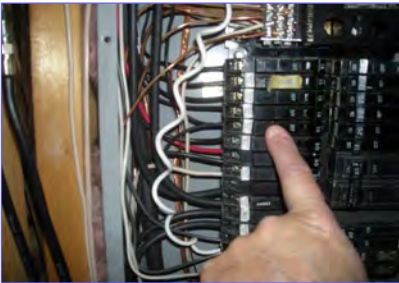
Circuit Breakers

- v A breaker is serving two circuits. This could lead to overloading of the circuit. This is commonly called a double tapped breaker. This condition should be evaluated by an electrician and repaired as needed.

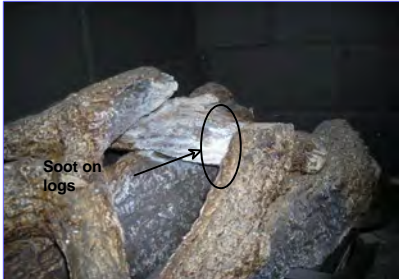
Gas Logs

- √ There is soot on the logs in the gas fireplace. This usually indicates that it is not burning properly. This could be due to damage to the burner, misplacement of the logs or other factors. It should be checked by a licensed technician. The fireplace not burning properly can cause an unsafe condition such as excessive carbon monoxide.

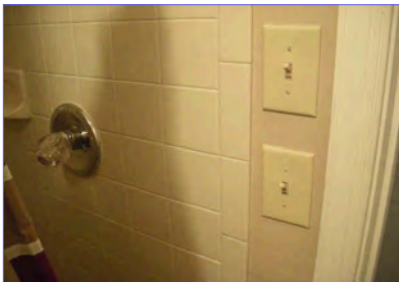
Lights

- √ There is a switch or electrical plug that is too close to the tub or shower. All switches and plugs should be out of reach of the tub or shower to prevent electrical shock. The switch or plug should be moved for safety.

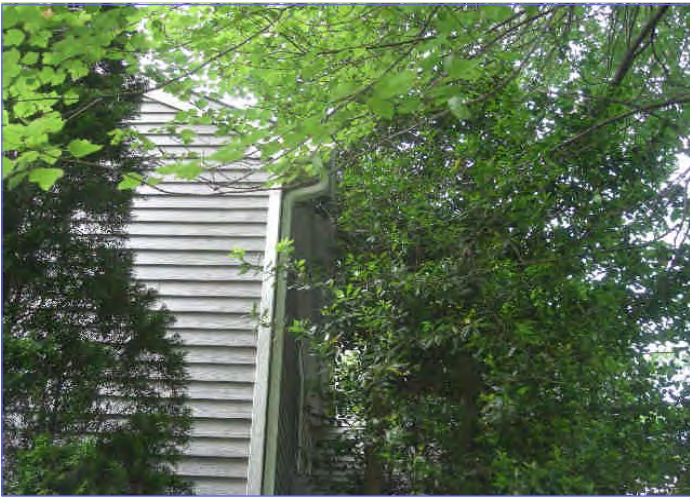
- q Plants are too close to the house and should be kept a minimum of twelve inches away for the general welfare of the walls and foundation. Plants against the walls can stain the finish and hold moisture against the house.

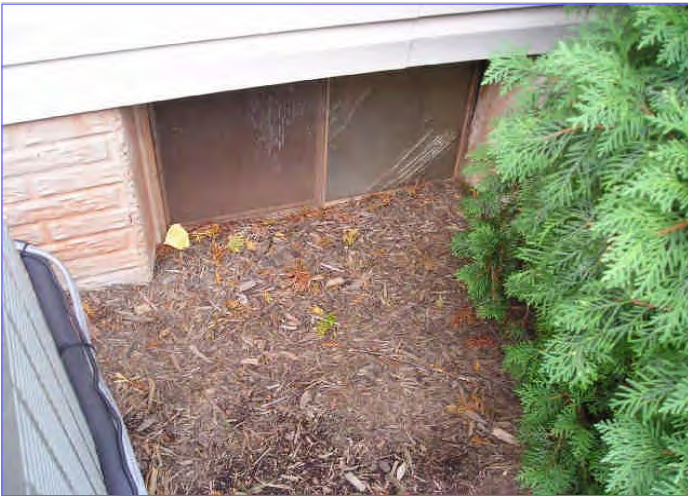
- The mulch in the flower beds around the residence is too high up on the sides of the house. This can make it easier for moisture and pest to enter the house. Any grading should be at least 4 inches below the top of the foundation and below the weep holes in brick veneer. The outside grading should be corrected to keep moisture away from the house and still allow for proper slope to facilitate drainage away from the house.

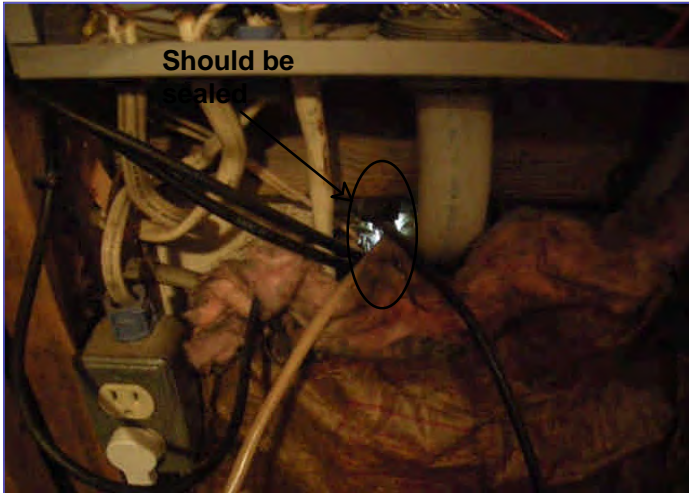
- There are gaps at the penetrations in the siding that should be sealed, such as around pipes and wires that come through the siding.

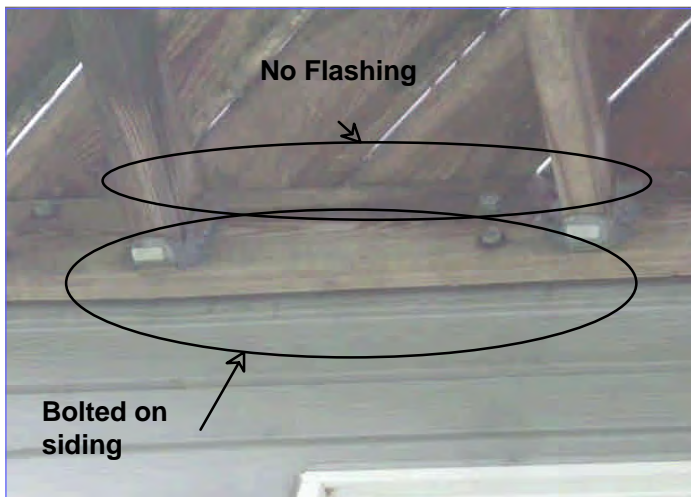
- q There does not appear to have any flashing at the ledger board. This is a metal strip that covers the board that attaches the deck to the structure. It is meant to keep water off of this area to prevent deterioration. This area should be monitored for rot or deterioration.

- q The wood deck needs to be cleaned and treated with a preservative. This is part of normal maintenance and should be done on a regular basis to prolong the life of the deck. This mainly concerns the area going down to the water.
- q The deck ledger board, which attaches the deck to the house, has not been installed properly. It is installed on top of the siding. This can lead to premature deterioration in the area of the bolts that fasten the deck to the structure. The siding should have been cut away and the ledger board properly bolted directly to the structure with the proper flashing.

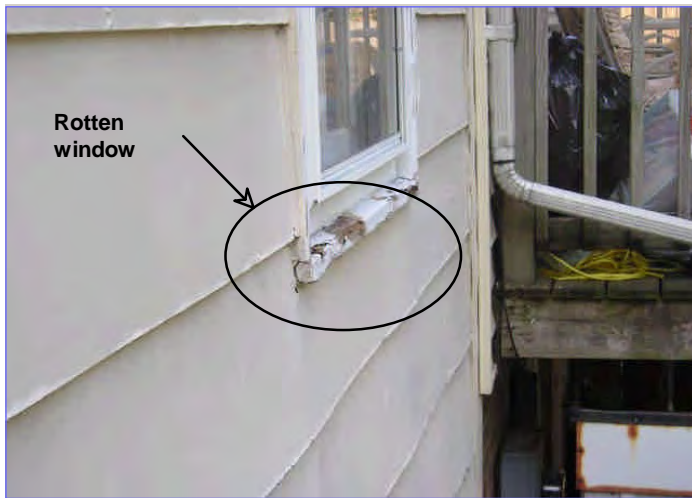
- ✓ The wooden fascia and trim on the outside of the house has peeling paint and rot. The rotten wood should be replaced and repainted. This may be an indication of delayed or poor maintenance. There may be other areas that need repair that were not observed. Also the amount and depth of any moisture penetration cannot be determined until the damaged area is removed.

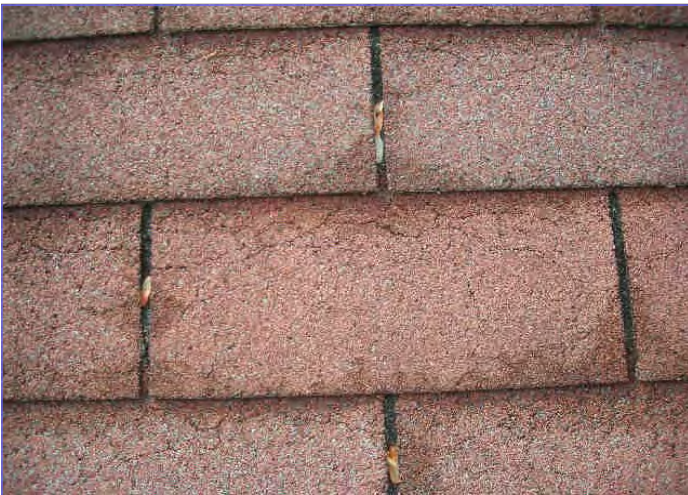
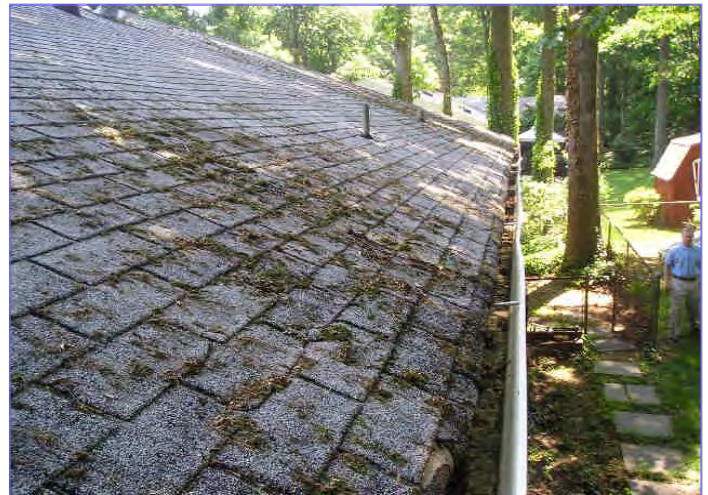
- q The roof is in the is showing sighs of decomposition, which means that the roof is in decline and susceptible to leaks. It will need to be maintained and closely monitored, because it is reaching the end of its serviceable life.

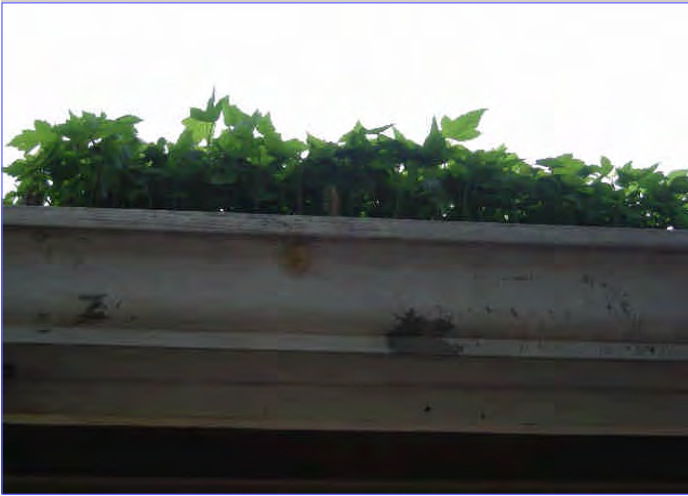
- q The gutters need to be cleaned to drain properly.

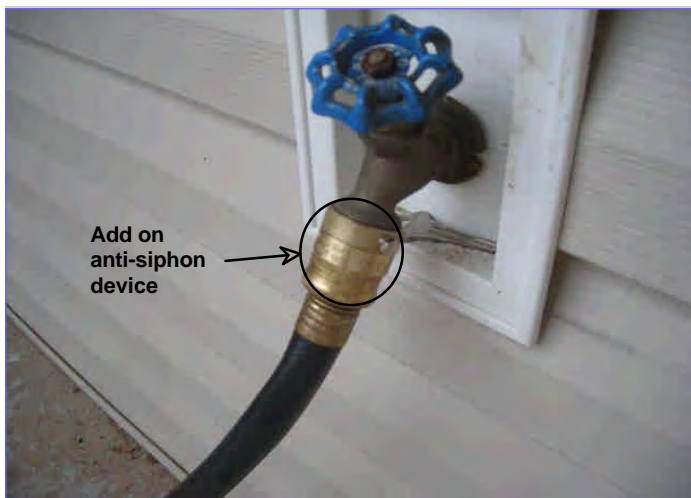
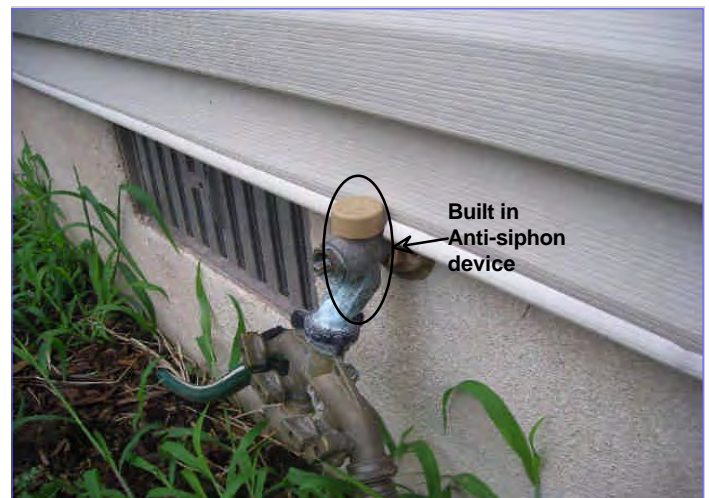
- Hose bibbs are the outside water faucets of the house. Since these are exposed to the weather they can freeze and burst in cold weather. Most have an inside cutoff and drain vent, so that the pipe going to the exterior can be drained before it gets too cold. Some of the hose bibbs are a "frost free" type. These have a long valve body that extends through the wall. This drains the valve through the wall to the warmer interior each time the valve is turned off. Regardless of which type is used there should be a way to drain the hose bibb to keep it from freezing.
- All hose bibbs should have a device to make sure that water from the hose cannot siphon back to the house or public water supply. Normally there are two types of anti-siphon devices. One is installed on the hose bibb and the other is built in to the hose bibb. These are often called back flow preventers.

- The interior cutoff for the hose bibbs were located. These should be turned off in winter and drained to prevent freezing.

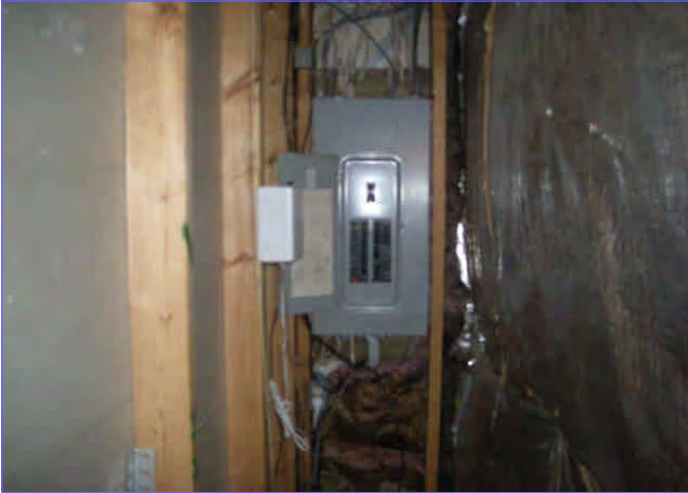
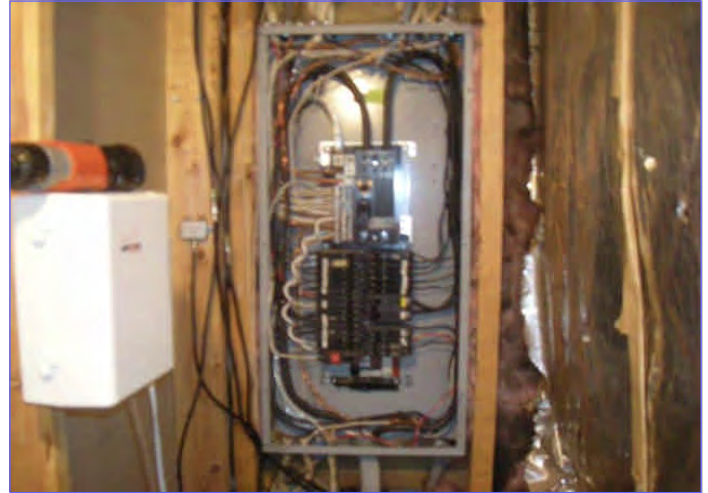
- The residence is served by a 200 amp, 220 volt panel, located at the rear of the basement

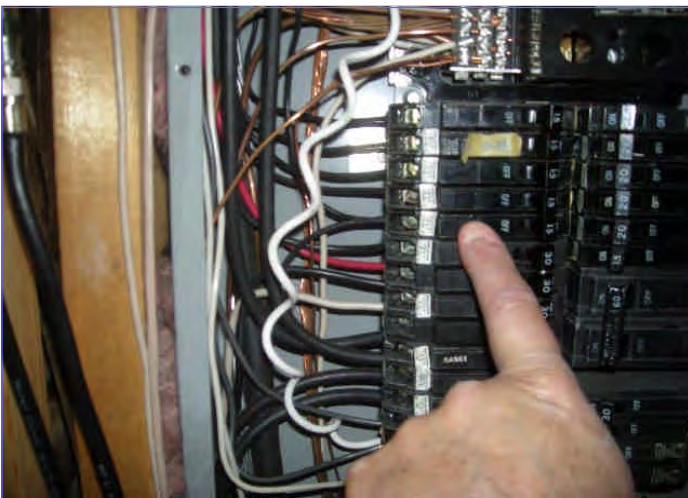
- ✓ A breaker is serving two circuits. This could lead to overloading of the circuit. This is commonly called a double tapped breaker. This condition should be evaluated by an electrician and repaired as needed.

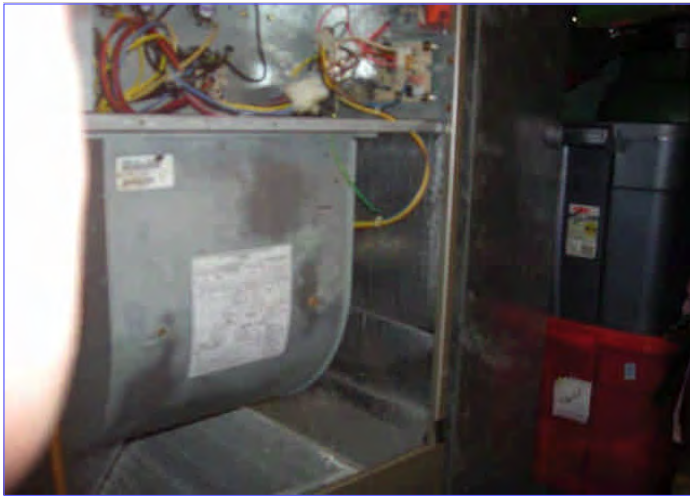
- The air handler is functional. This is the part of the furnace at houses the fan that circulates the air and the heating unit. The cooling unit is either inside this or mounted just after the air handler.

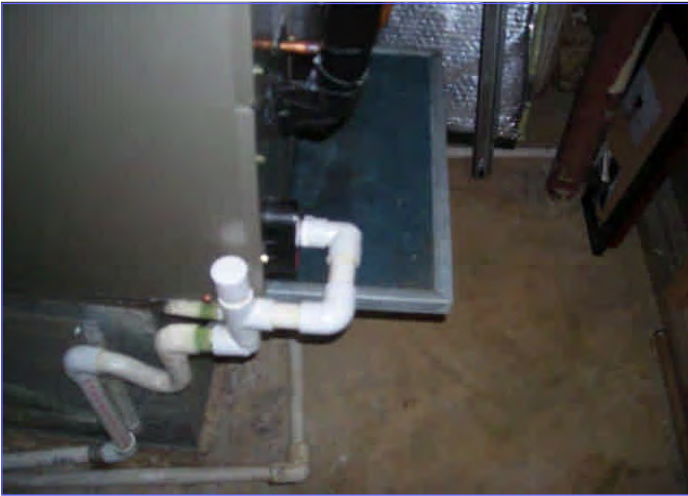
- The filter in the heating and/or air conditioning system should be kept clean. This will provide cleaner air in the house and keep the system working properly. A dirty filter forces the fan to work harder than it should, thereby using more power. A dirty filter can allow dirt into the air circulation equipment that can cause premature failure. It is recommended that most filter be changed or cleaned once a month.
- This system has an air filter that can be removed and cleaned and then reinstalled. It should be removed and cleaned approximately once a month.

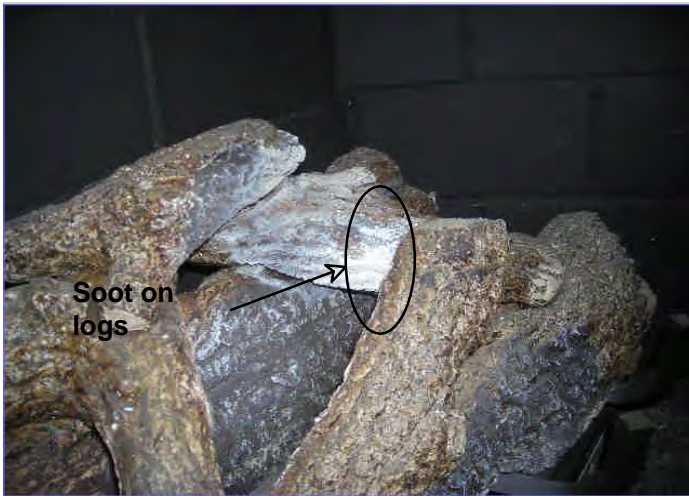
- ✓ There is soot on the logs in the gas fireplace. This usually indicates that it is not burning properly. This could be due to damage to the burner, misplacement of the logs or other factors. It should be checked by a licensed technician. The fireplace not burning properly can cause an unsafe condition such as excessive carbon monoxide.

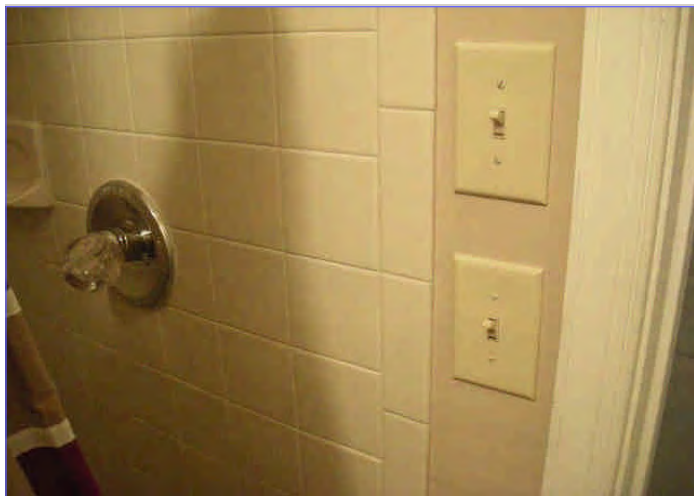
- ✓ There is a switch or electrical plug that is too close to the tub or shower. All switches and plugs should be out of reach of the tub or shower to prevent electrical shock. The switch of plug should be moved for safety.

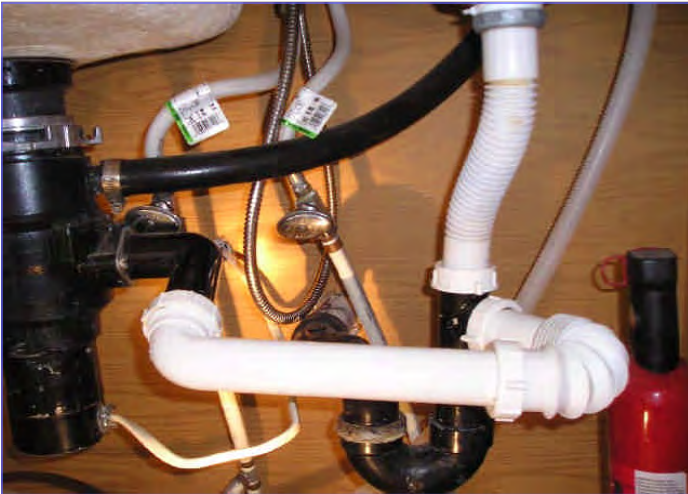
- Q The sink employs a flexible drainpipe that could contribute to blockages and leaks. It should be replaced by a strait smooth walled pipe. The ridges can trap debris that will clog the drain. They also have a tendency to crack and leak.

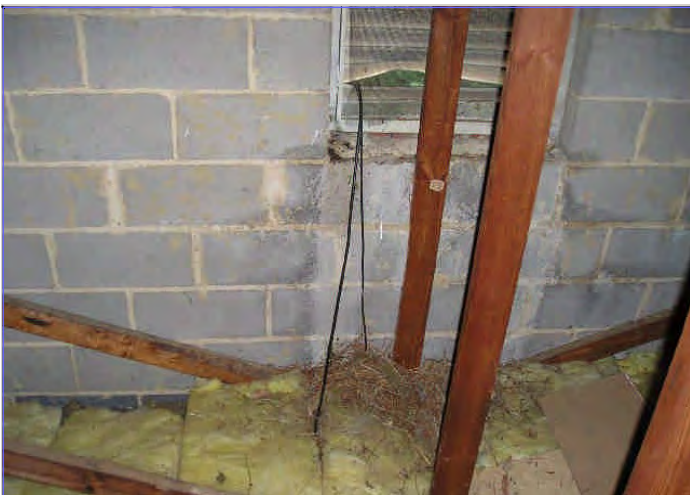
- ✓ There are signs that birds have gotten into and nested in the attic. Birds can pose a health risk and cause structural problems. The nest should be removed and any possibility of access removed.

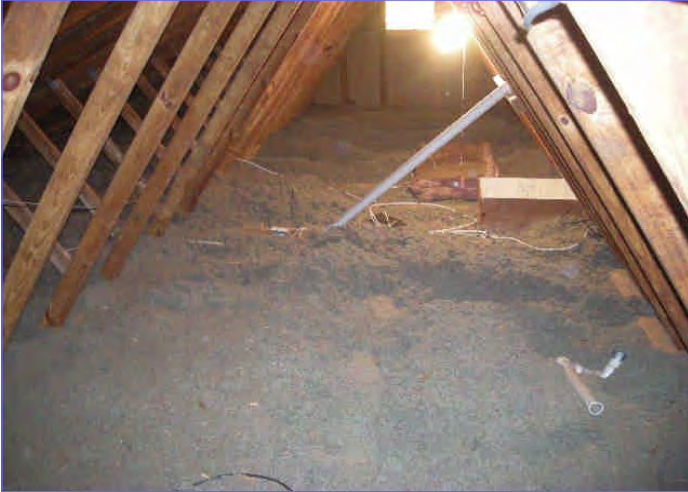
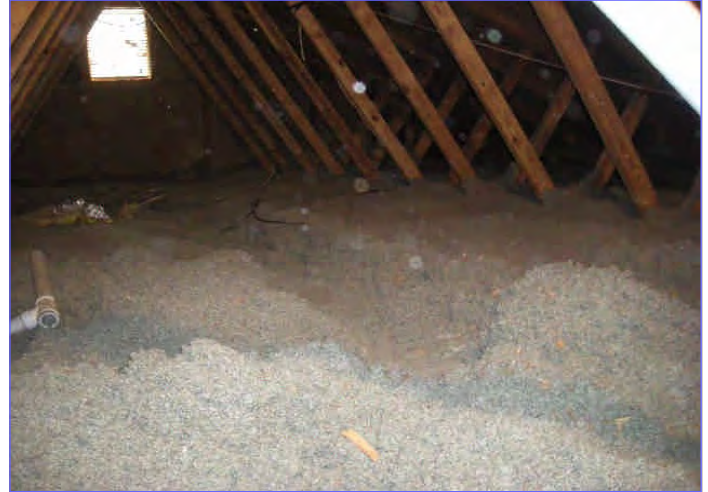
- We entered the attic and inspected the accessible areas. Normally not all areas will be accessible. Some will be blocked by insulation, ductwork, or roof framing.
